TREC REI 7-6

1234 Main Street
Austin TX 78759

01/17/2024 9:00AM

PROPERTY INSPECTION REPORT FORM

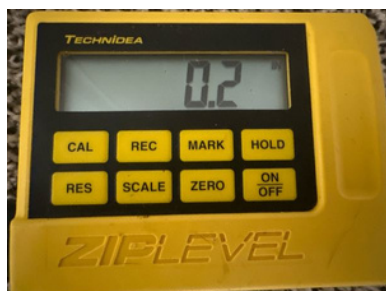
Zip Level Foundation Elevation Readings:

Zip Level Performing : Foundation elevations were measured throughout the home using a Zip Level. Point zero was set at the center of the home and measured through each side of the residence (only interior, excluding the garage). Variances detected in a slab can indicate possible signs of settlement. Based on these readings, the foundation appeared to be performing as intended at the time of the inspection.

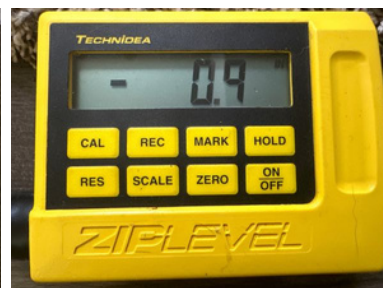
Front Left, with laminate variance

Laminate Drop Variance

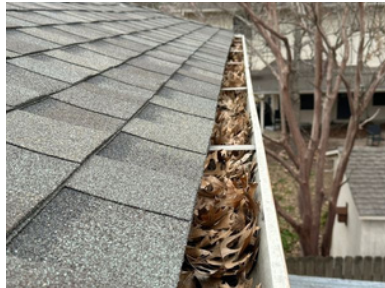
Gutters were filled with debris/foilage. These gutters should be cleaned to allow for proper drainage.

Recommendation: Contact a qualified professional.

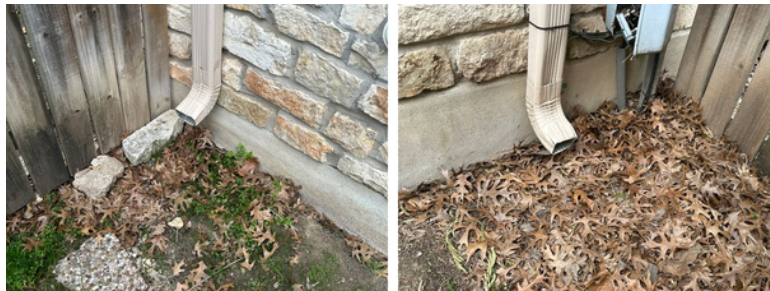
2: Missing Splash Blocks

The gutter downspouts are missing splash blocks. These should be added to prevent soil erosion.

Recommendation: Recommended DIY Project

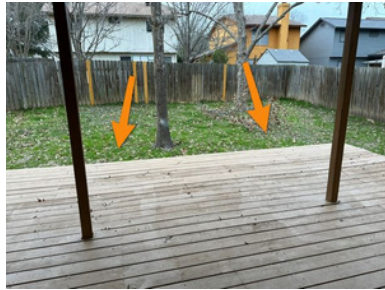
3: Negative Grade

Negative grading observed, which may result in moisture damage due to improper drainage toward the structure. Soil should slope away from a structure declining 6 inches in the first 10 feet.

Recommendation: Contact a qualified landscaping contractor

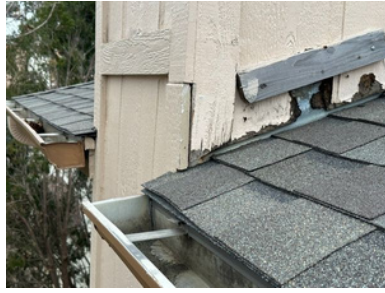
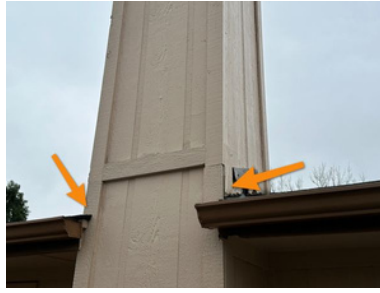
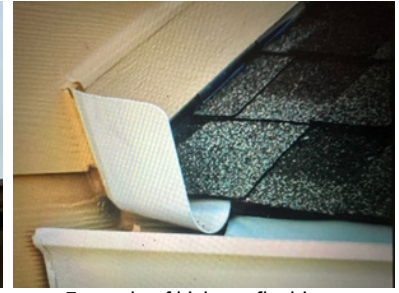
1: Missing Kick out Flashing

The roof covering is missing kick-out flashings along lower adjacent siding materials.

Recommendation: Contact a qualified roofing professional.

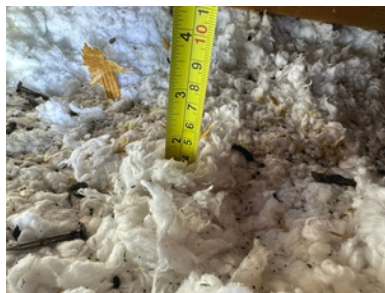
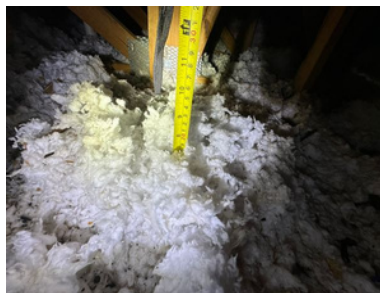
Roof/shingle debris and cardboard debris were present in the attic at the time of inspection.

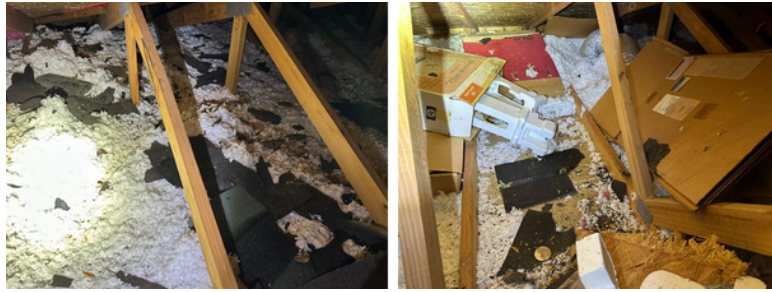
The inspector could not access or view all areas of the attic due to a limited/absent walkway.

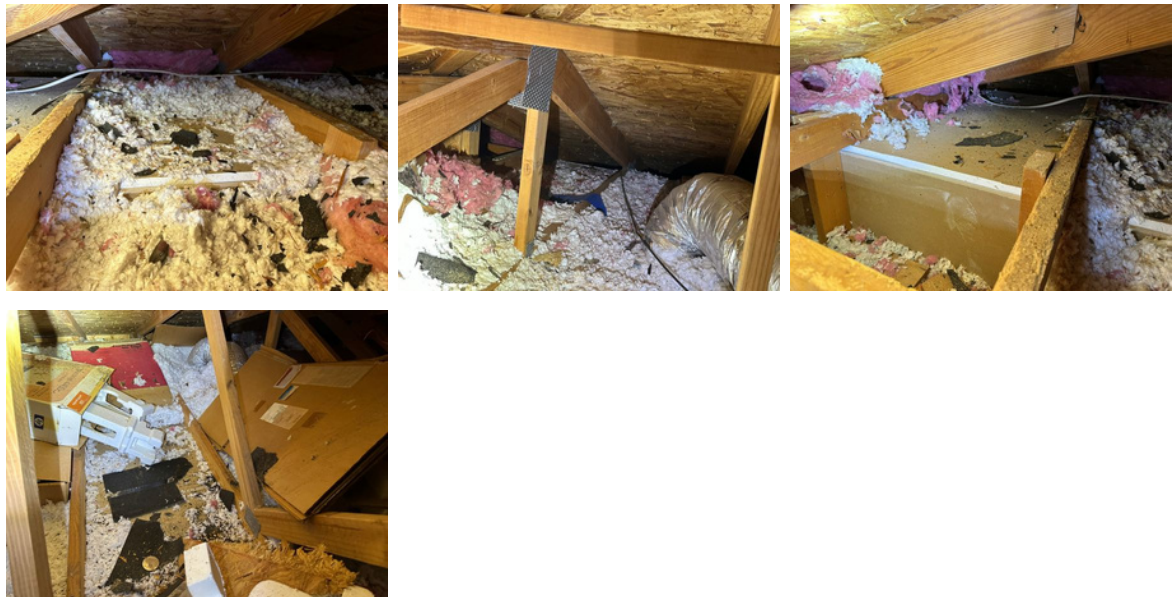
Compressed or displaced insulation was observed in the attic space. Insulation voids were observed. Compression of insulation materials can decrease the energy efficiency of the residence.

Recommendation: Contact a qualified insulation contractor.

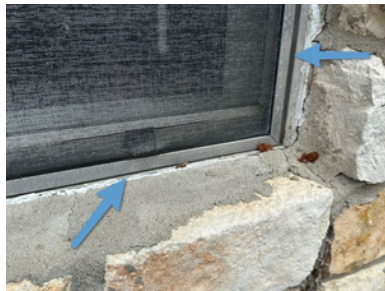
3: Damage Present

Damage observed to the siding materials.

Recommendation: Contact a qualified siding specialist.

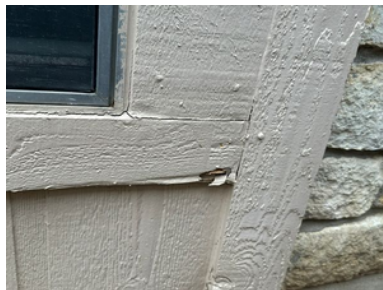
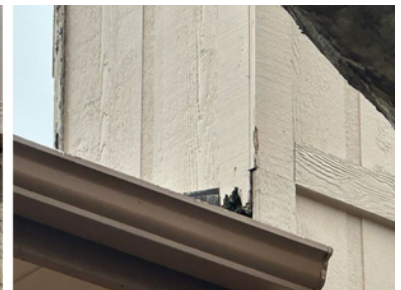
5: Wood Rot / Water Damage

Wood deterioration/rot was observed at siding/trim.

Recommendation: Contact a qualified professional.

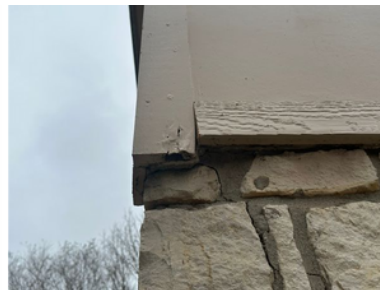
🔴 Major or Safety Concern

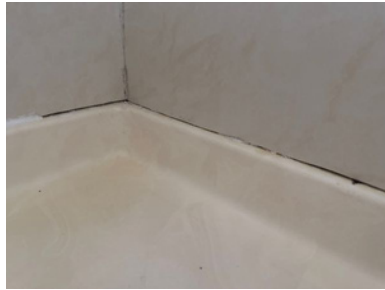
Gap(s) / crack(s) present to the grout/sealant joint(s) located in the bathtub/shower enclosure. Recommendation: Contact a qualified tile contractor

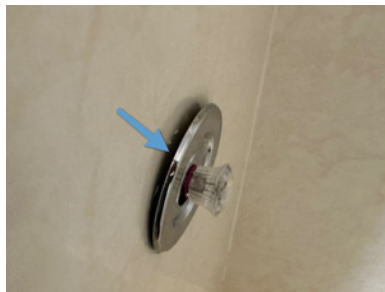
8: Shower/tub Fixture(s) Not Properly Sealed

The shower/tub fixture(s) and valve(s) should be properly sealed with the shower/tub wall.

Recommendation: Contact a handyman or DIY project

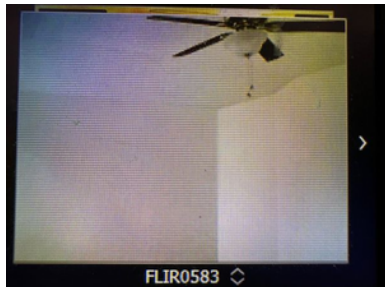
Master Bedroom

Thermal imaging scan: Evidence of missing/deficient insulation was observed.

Recommendation: Contact a qualified general contractor.

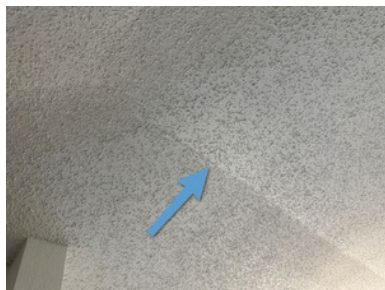
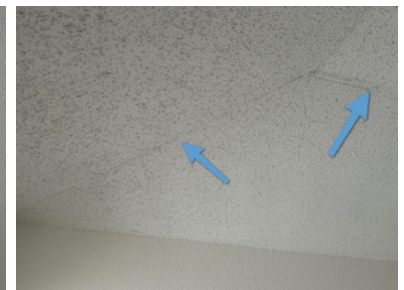
1: Ceiling Seam Cracks

Seam crack(s) were observed to the ceiling drywall in multiple locations.

Recommendation: Recommend monitoring.

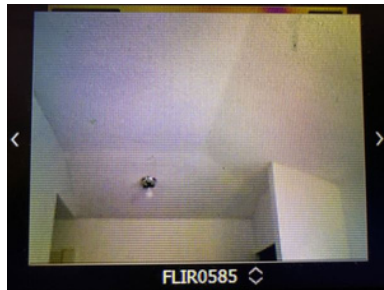
Master Bathroom

Thermal imaging scan: Evidence of missing/deficient insulation observed.

Recommendation: Contact a qualified insulation contractor.

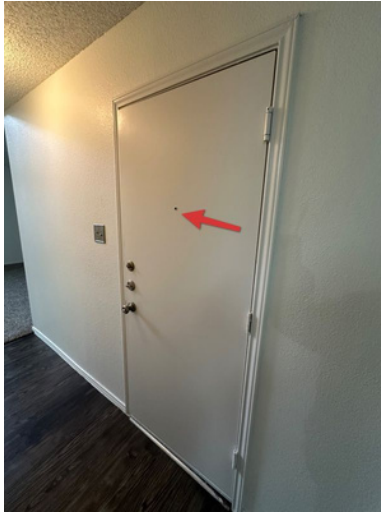
2: Missing Fire Rated Garage Door

A solid wood door or properly fire-rated door is missing between the garage and residence.
Recommendation: Contact a qualified handyman.

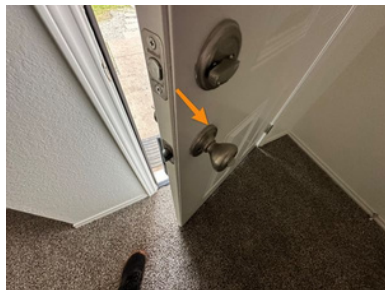
**6: Doorknobs Loose**

Loose doorknobs observed.

Recommendation: Contact a qualified professional.

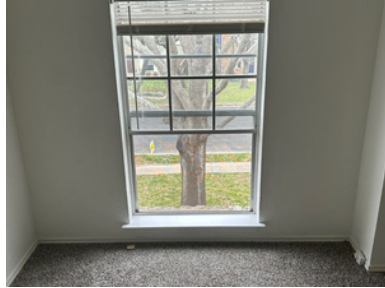
**3: Lift Supports****⚠Moderate Concern**

Living Room

Window lift support is loose, damaged

Recommendation: Contact a qualified professional.

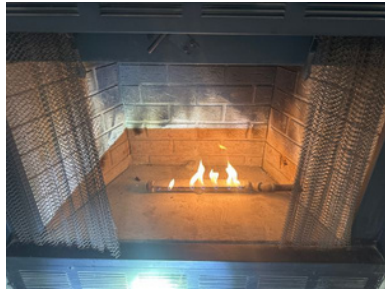
**1: Missing Damper Clamp**

A missing damper clamp was noted inside the fireplace flue above the firebox. This device is required for all gas-fueled fireplaces.

Recommendation: Recommended DIY Project

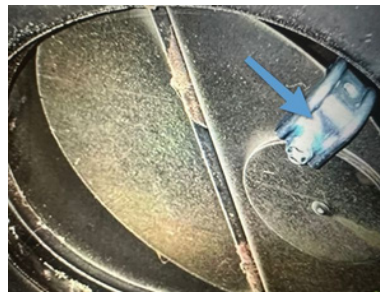
Example of damper clamp

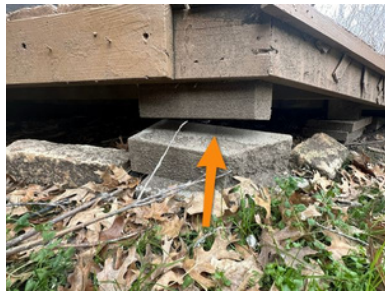
3: Improperly Supported

Deck structure was not supported properly. Tree roots are causing deck deflection.

Recommendation: Contact a qualified professional.

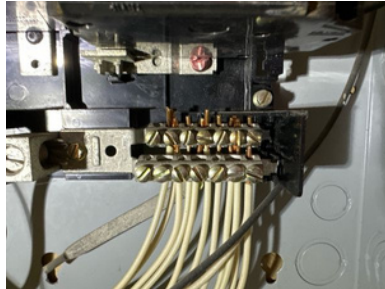
Double taps were observed to the neutral bus at the subpanel. This configuration is improper, as it can cause electrical arcing or overheating. Recommend further evaluation by a licensed electrician.

Recommendation: Contact a qualified electrical contractor.

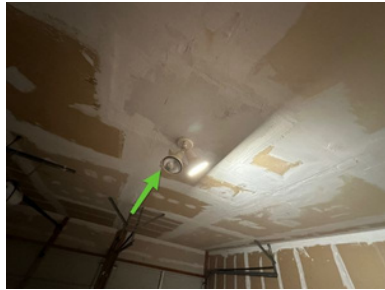
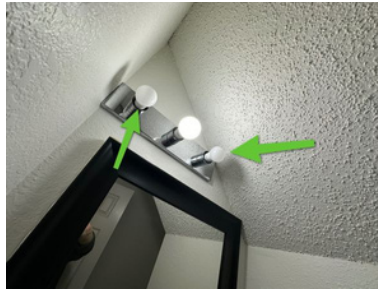
Missing at kitchen

**1: Missing GFCI Protection****Moderate Concern**

Missing GFCI protection for outlet(s). Missing at exterior, dishwasher/disposal, laundry room. Partial at kitchen and garage.

Recommendation: Contact a qualified electrical contractor.

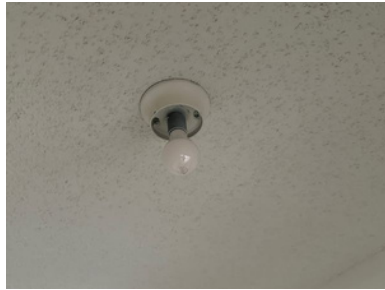
**4: Missing Permanently Installed CO Detectors**

The carbon monoxide detector in the home was not permanently installed (installed into a wall outlet) or interlinked with the smoke detectors. Recommend addition of an electrically hard-wired, interlinked device with a battery backup.

Recommendation: Contact a qualified professional.

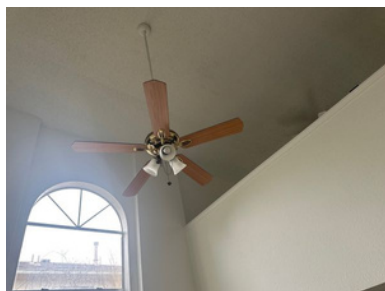
Living Room

7: Pull Chains Inadequate Length

The pull chains were not long enough for the fan/light controls at the overhead ceiling fan.

Recommendation: Contact a qualified handyman.

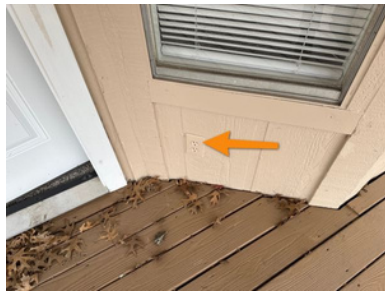
10: Missing Condenser Outlet

The exterior condenser was missing a nearby GFCI-protected exterior outlet (current standard).

Recommendation: Contact a qualified electrical contractor.

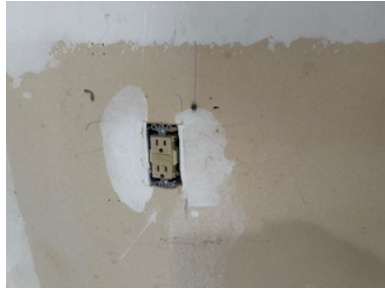
15: Receptacles Not Tamper Resistant

Receptacles were observed less than five and a half feet above the floor that were not tamper resistant. Recommendation: Contact a qualified professional.

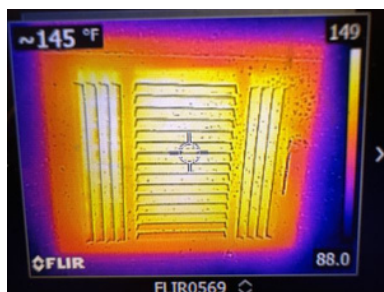
1st Floor Back Living Room

Inconsistent temperature observed at the registers throughout the home. With the thermostat set to 75 degrees, warm air was detected between 99 and 155 degrees (more than a 5 degree variance between supply registers). Recommend further evaluation by an HVAC specialist to ensure the system is properly balanced.

Recommendation: Contact a qualified HVAC professional.

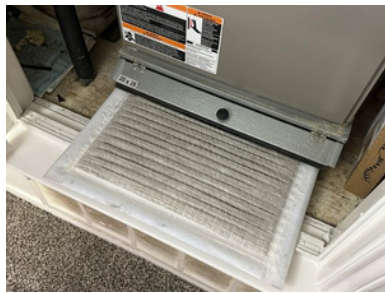
Back Left Bedroom

Registers at rear guest bedroom are not connected to HVAC system. Registers are linked together by a duct in the attic.

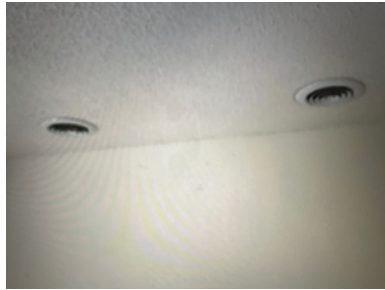
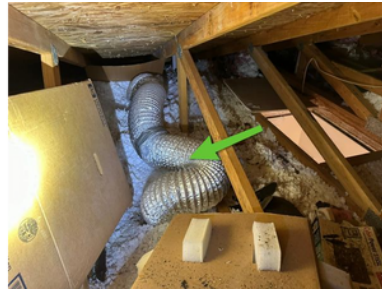
**1: Inconsistent Temperature**

Inconsistent air temperatures were observed between the registers throughout the home. Recommend further evaluation by an HVAC specialist to ensure the system is properly balanced.

Recommendation: Contact a qualified HVAC professional.

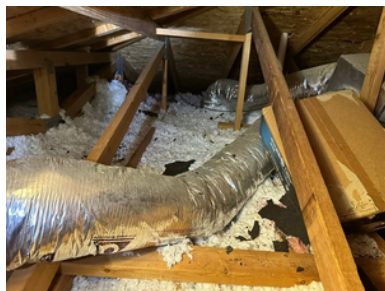
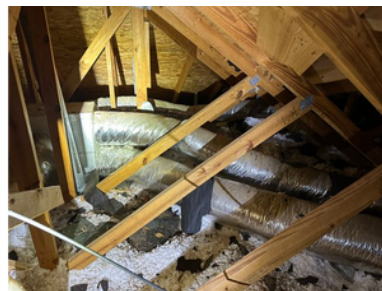
**3: Plenum Not Sealed**

The air handler plenum is not properly sealed. Air loss detected. Recommend sealing the system to ensure maximum performance.

Recommendation: Contact a qualified professional.

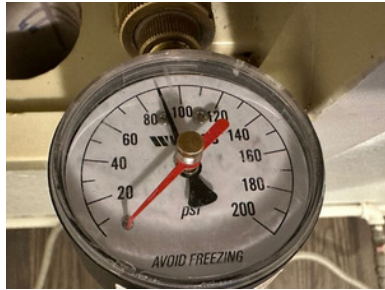
The static water pressure measurement was above 80 PSI. 80 PSI is limit for long-term durability of plumbing fixtures. Whenever water pressure exceeds 80 PSI, a pressure reducing valve (PRV) should be in place to protect the plumbing system. Recommend further evaluation and/or remediation by a licensed plumber.

Recommendation: Contact a qualified plumbing contractor.

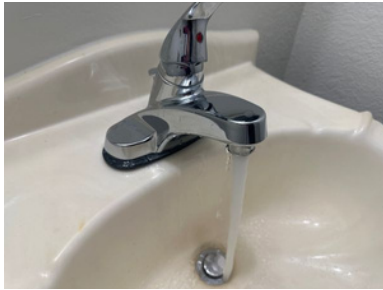
6: Hot/Cold Reversed

The sink faucet Hot and Cold are reversed in the upstairs bathroom

Recommendation: Contact a qualified professional.

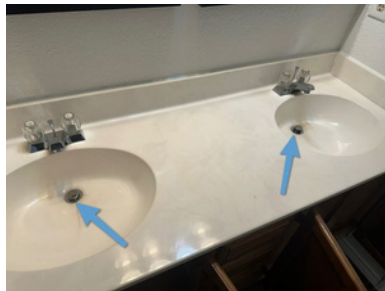
The drain stop was not functioning as intended.

Recommendation: Contact a qualified plumbing contractor.

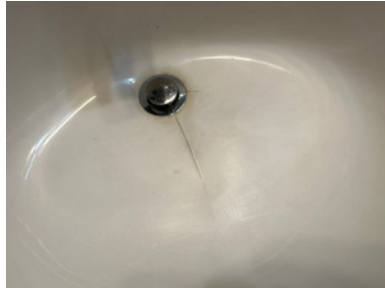
The surface finish was damaged at the sink.

Recommendation: Contact a qualified professional.

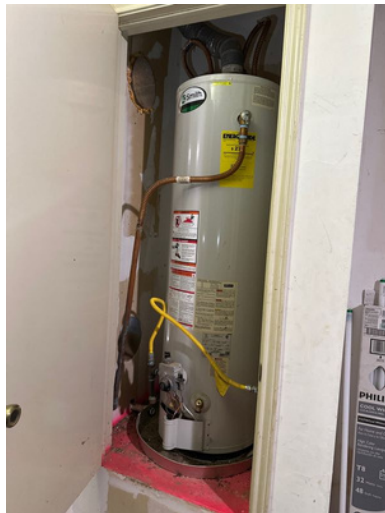
Energy Source: Gas Fueled

Location: Garage

Year Manufactured:

2014

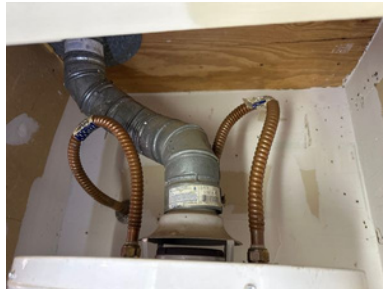
1: Insulation Missing

Insulation was missing or incomplete for the supply/delivery lines at the water heater.

Recommendation: Contact a handyman or DIY project

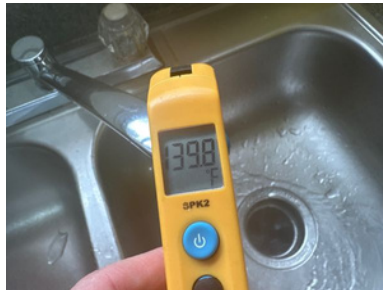
2: Excessive Temperature

🟡Moderate Concern

Excessive hot water temperatures (over 120 degrees) was observed. Recommend further evaluation. Recommendation: Contact a qualified plumbing contractor.

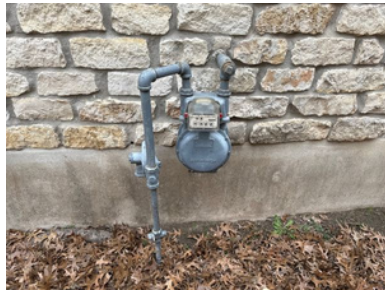
Location of Gas Meter: Exterior of the home

*Type of Gas Distribution Piping Material:*Black Iron

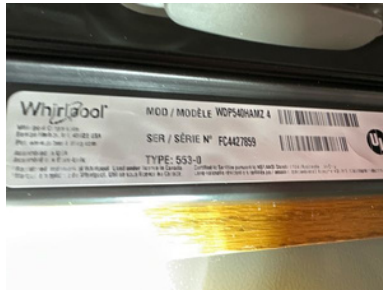
Dishwasher Data Plate:

Performed:

The dishwasher was inspected and operated in 'Normal' mode and performed as intended.

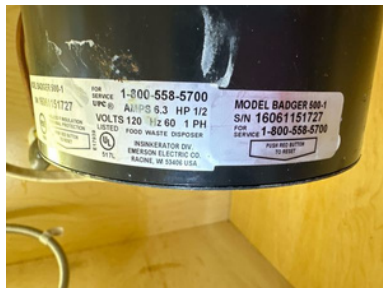
Disposal Data Plate:

Performing: The unit was operated and appeared functional at time of the inspection.

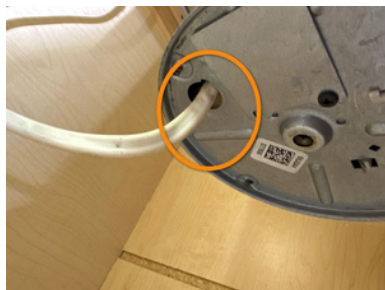
1: Fitting

The disposal was missing an electrical fitting at the base of the unit. Recommend addition to prevent damage to the electrical wiring for the unit.

Recommendation: Contact a qualified professional.

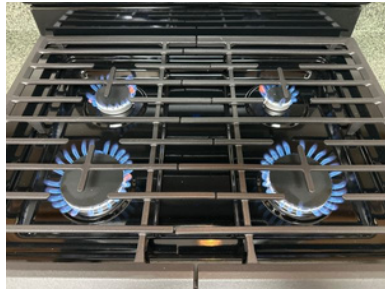
Oven Performing:

The oven operated as intended when tested. The unit was tested at 350 degrees. (Allowable temperature range is 325-375 degrees)

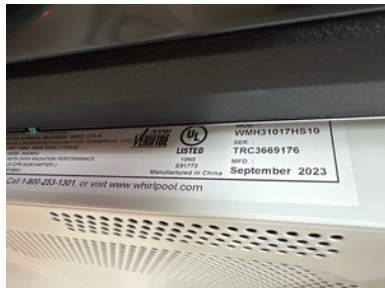
Microwave Data Plate:

Performing: The unit was tested using an LED microwave indicator. No deficiencies are present to report.

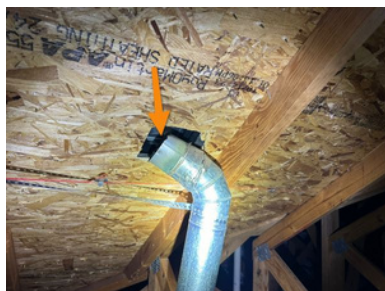
The exhaust fan ductwork/flue did not extend to the exterior of the residence.

Recommendation: Contact a qualified professional.

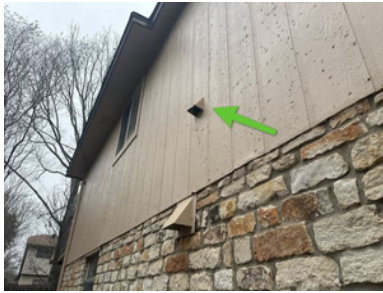
**1: Lint**

▲Major or Safety Concern

Trapped lint was observed in the visible dryer vent flue at the time of the inspection. Recommend cleaning the dryer line to prevent a potential fire hazard.

Recommendation: Contact a handyman or DIY project

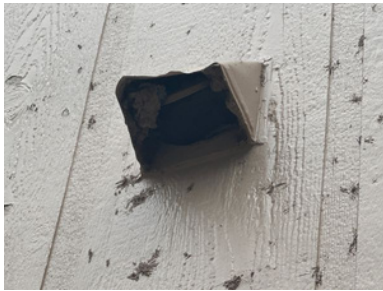
The dryer vent cover flap does not seal properly with the exterior wall. This presents a possible intrusion point for pests.

Recommendation: Contact a handyman or DIY project
